**Entergy Nuclear Northeast  
Entergy Nuclear Operations, Inc.**

December 4, 2012  
JAFP-12-0148

**SUBJECT:** LER: 2012-005, Transformer Installation Error Causes Loss of Off-Site  
Power  
James A. FitzPatrick Nuclear Power Plant  
Docket No. 50-333  
License No. DPR-59

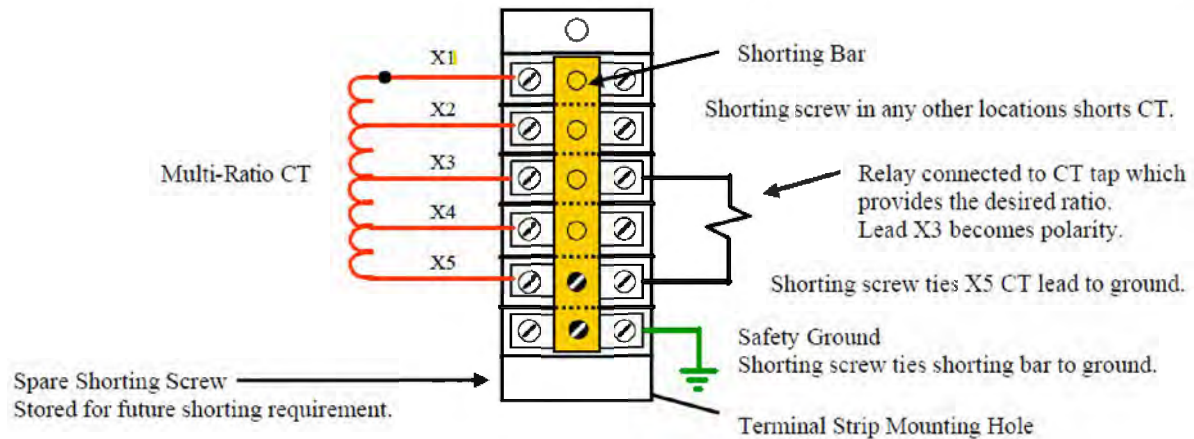
**Figure: CT Termination Block**

The transformer CT lead connections are made in the transformer control panel on shorting terminal blocks. These shorting terminal blocks are equipped with a conductive bar (shorting bar), which is isolated from the block's termination points.

The shorting bar is grounded at one end and equipped with holes over each termination point. The holes are used to allow the installation of a machine screw to connect the shorting bar to a termination point, thereby grounding the CT. See Figure below:

The transformers are shipped from the factory with the CT shorting bars installed. The manufacturer installed the shorting bars in order to prevent the generation of high voltages in the CT. This precaution protects equipment and personnel safety during transport and storage. The drawing with this factory configuration was included with the work order package used during installation.

The drawing given to the installing contractor was incorrect and showed the shorting bars installed in the CTs. The work order however, contained the appropriate step to remove the shorting bars on the CT terminal blocks for CTs that would be placed in service. Workers questioned this discrepancy and after some review, were directed by the responsible JAF engineer to install the transformer per the drawing. The supervisor for the installing contractor subsequently signed off the work order step indicating the shorting bars were removed and that the step had been verified by engineering.

The root cause of this event was an individual not performing the work order steps as written. The contributing causes were conflicting information between the drawing and the work order instructions; inadequate verbal communication between the project manager and the responsible engineer; and inadequate review of the engineering change in accordance with new requirements specified in revision 6 of EN-DC-149, "Acceptance of Vendor Documents."

- Performance counseling was performed by the contractor companies for individuals involved with this event.
- The drawing has been updated to reflect the current operational configuration.
- The CT configuration for both RSSTs, 71T-2 and 71T-3, was corrected.
